## Specific problem solution and distant learning

David L. Kastler  
*University of Northern Iowa*

This document is an overview of a project to identify the cause of a coolant overheating complaint on a diesel engine that powers a mechanical lift machine, implement a short-term solution and place into action a long-term solution. The short-term correction was to make necessary repairs in the field, long-term solution includes distant training of the mechanical lift machine assembly line and training on the proper assembly procedure of assembling the alternator pulley to the alternator shaft.

A Graduate Project Paper

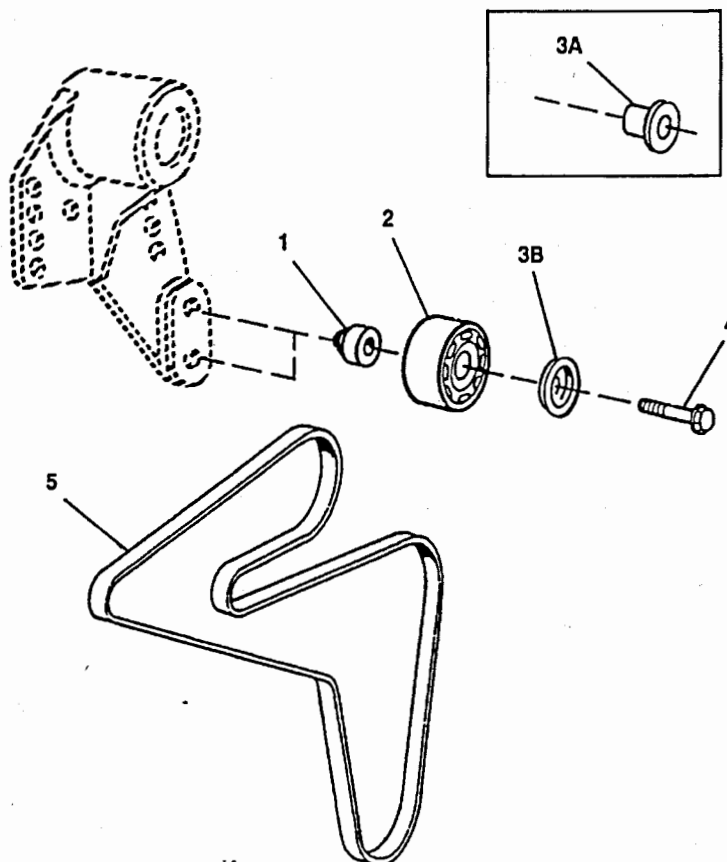
**Solution:**

Replace R500352 Cover (3B) on idler pulley with R107749 Sleeve (3A).

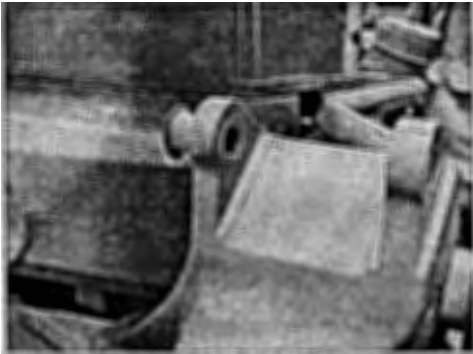
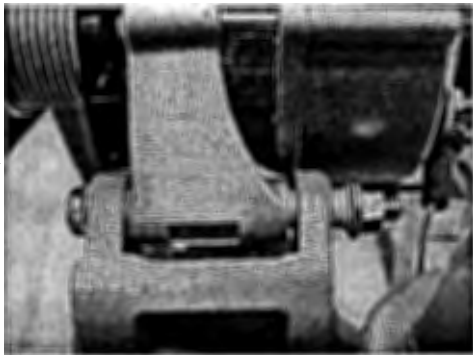
The bushing is partially assembled before the final torque is given. We do not have an established limit to where the bushing must be introduced. The final position is given when the nut is torqued.

In these pictures you can see how the bushing was first assembled and how it ended up when the nut was torqued.

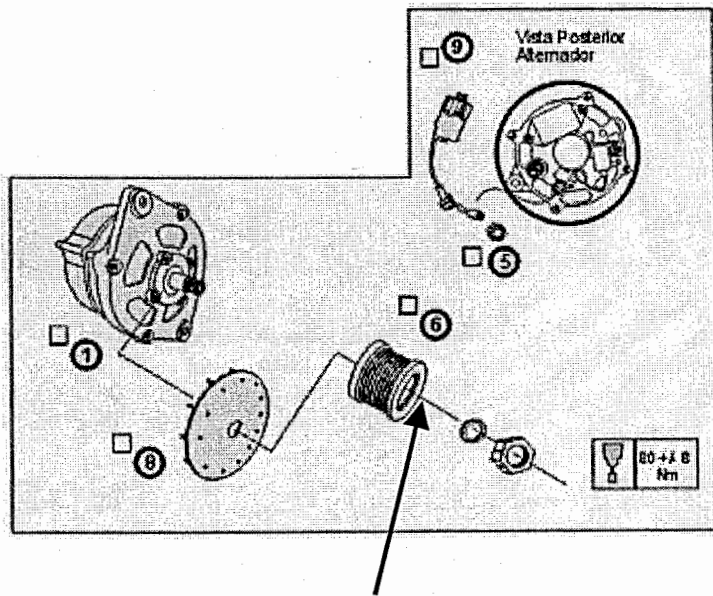
Needs R94351 collar

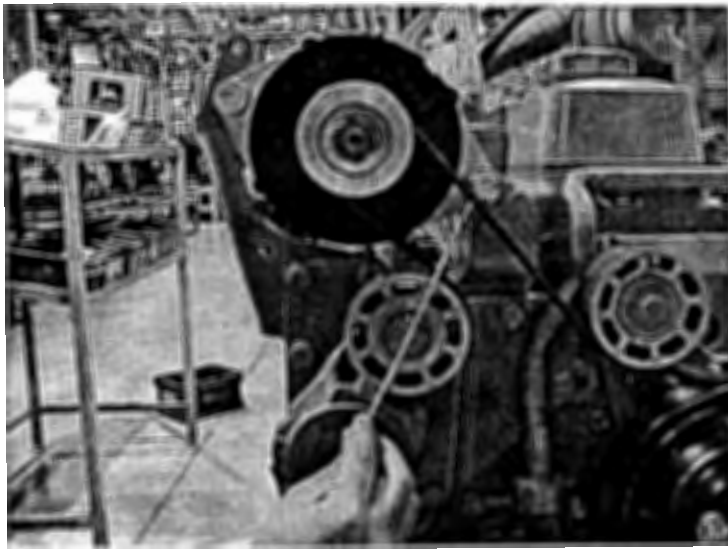
The height of the fan and crank pulleys are verified with a height gauge. The distance between the centers is measured. Other than that, the only revision we make is verifying that the tensioner bolt is aligned with the alternator right hand side bolt (alignment shown in picture). This is not a formal check in our process. However, all the operators are aware of this quick check.

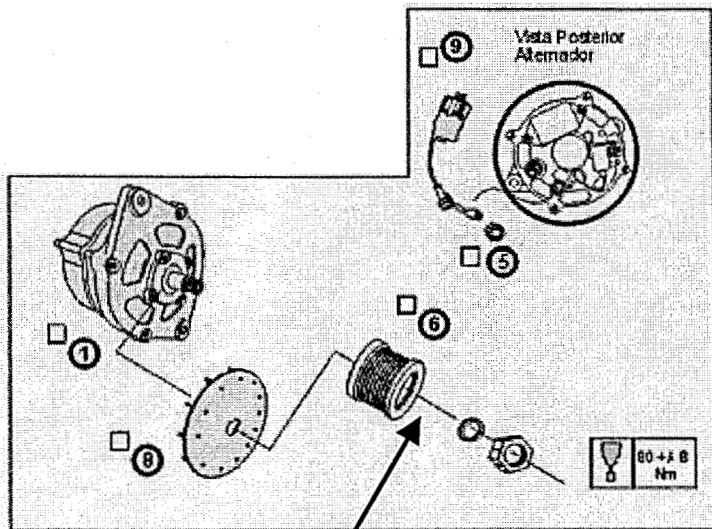
### Wrong Assembly

Missing Collar

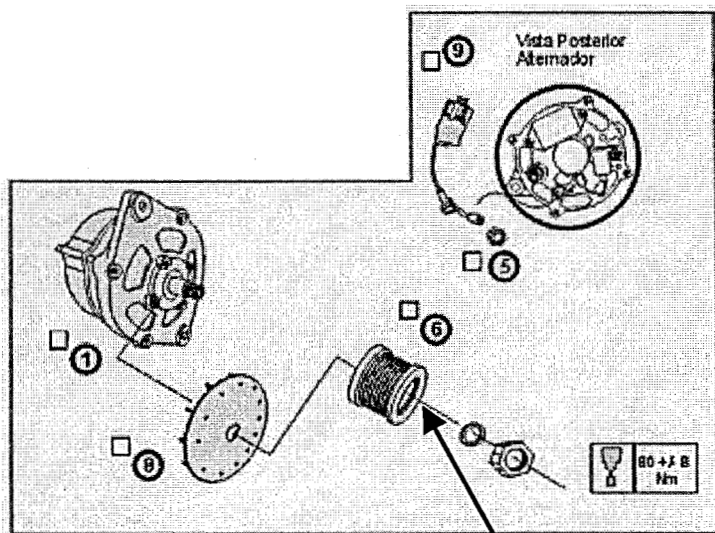
Location for R94351 collar

- Install R94350 Pulley and R94351 collar onto alternator shaft.

- Tighten alternator pulley retaining nut to 80 +/- 8 Nm.
